APPLICATION FOR PERMIT TO CONSTRUCT ACROSS OR ALONG A STREAM
AND / OR WATER QUALITY CERTIFICATION

**Mitigation Plan
For the
East Fork Little Sandy River #4
Lawrence County**

**For the
Kentucky Department of Fish and Wildlife Resources**

November 2008

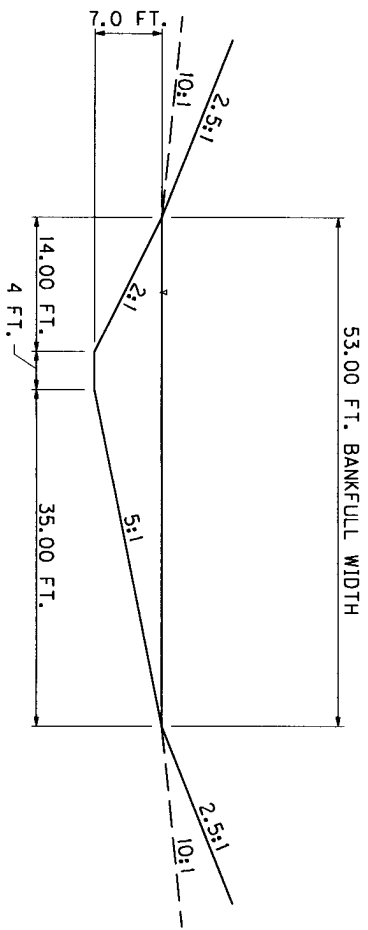
Bankfull Area = 199.5 sq. ft.
Wetted Perimeter = 55.3 ft.
TYPICAL POOL CROSS SECTION
STA 100+00 TO 119+77

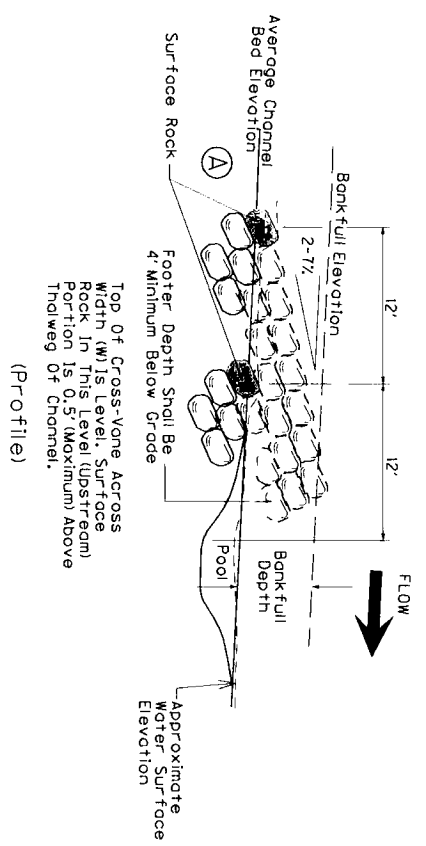
DOUBLE INVERT CROSS VANE & J-HOOK ROCKFILL

Material Excavated For Placement Of Footer Rock Shall Be Used As Backfill Upstream Of the Cross Vane. Between The Vane Arms And Bankfull, Backfill Shall Not Be Placed Upstream Of The Cross Vane In Width 'W' (See Plan View) Except To Replace The Channel Bed To Grade If Disturbed During Cross Vane Construction.

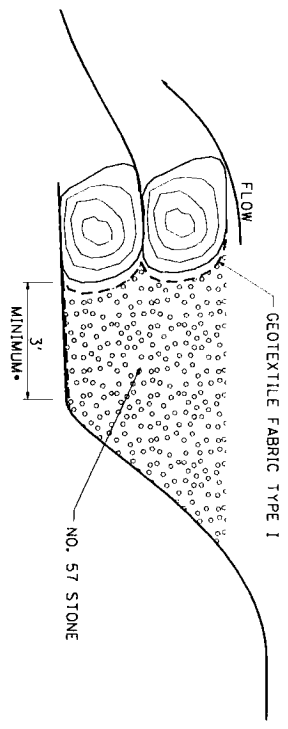
SECTION VIEW: LOG VANE

•GEOTEXTILE FABRIC SHALL EXTEND A MIN. 3' BEHIND THE FOOTER LOC.

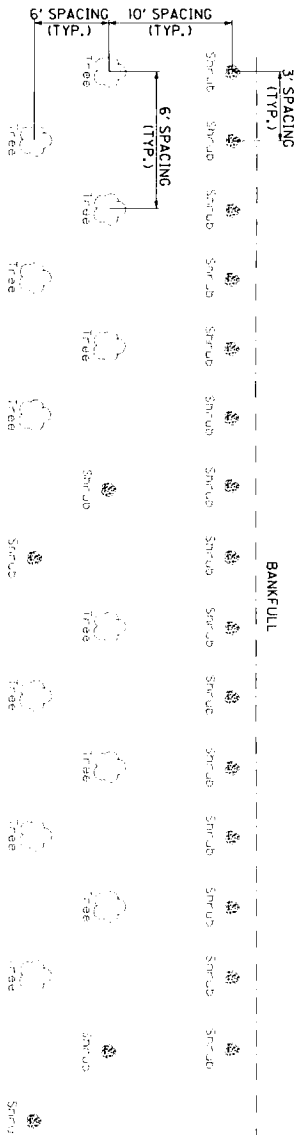
- NOTE:
1) THE FIRST ROW OF PLANTINGS SHALL CONSIST OF ALTERNATING SHRUBS. PLANTINGS SHALL HAVE 3' OF SPACING.

- 2) ADDITIONAL ROWS, BEGINNING 10' OFF THE SECOND ROW, SHALL CONSIST OF ALTERNATING TREES WITH AN ALTERNATING SHRUB AFTER EVERY THIRD TREE PLANTING. SEE THE PLANTING DETAIL FOR EXAMPLE OF PLANTING SEQUENCE. EACH ROW SHALL BE STAGGERED IN RELATION TO THE ROW BEFORE IT. SPACING BETWEEN PLANTINGS SHALL BE 6'x6'.

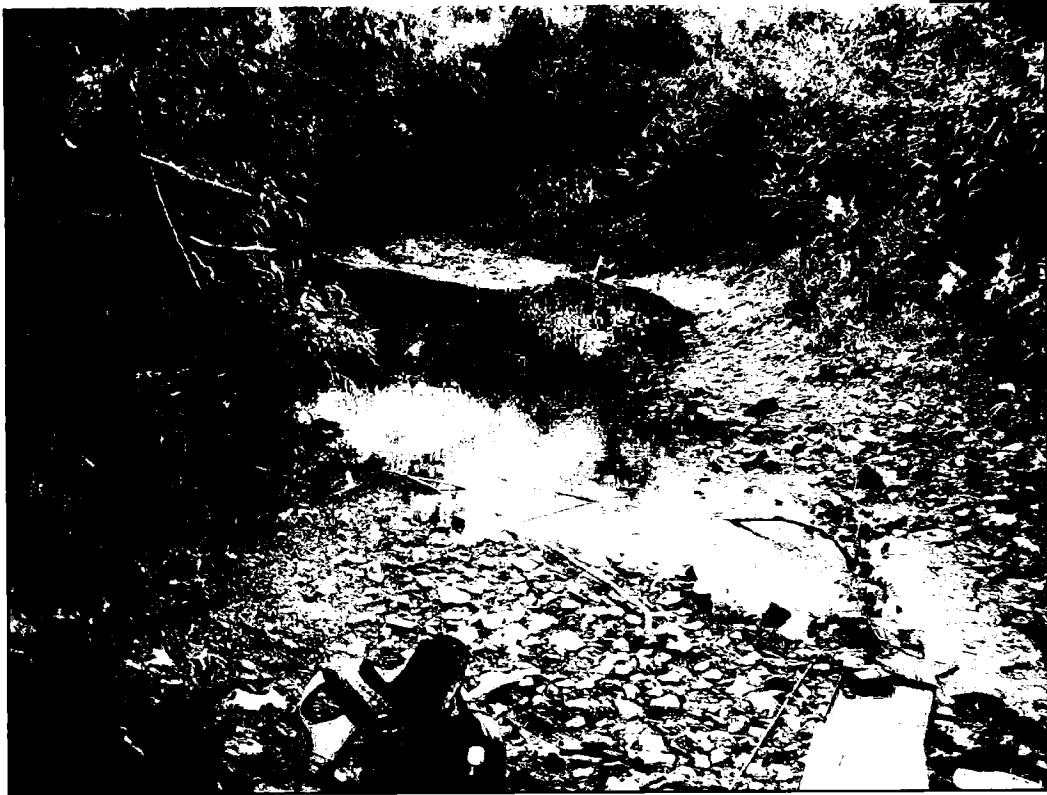
Assessment Point No. 1 – Looking upstream

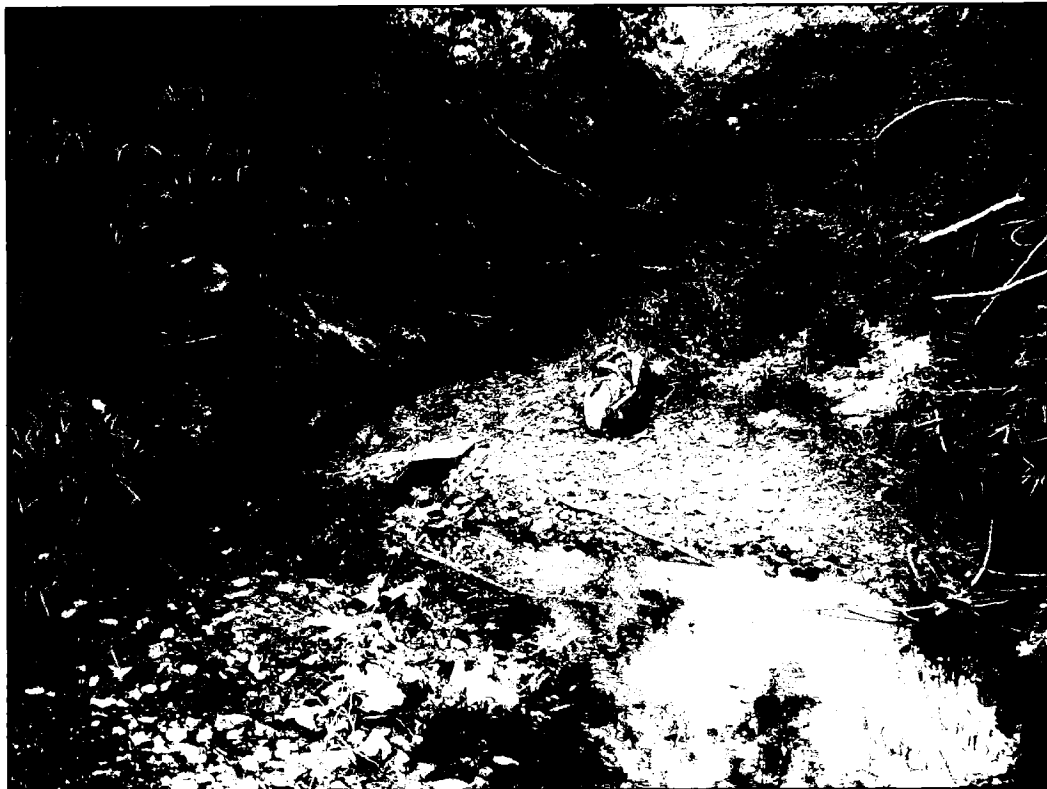
Assessment Point No. 1 – Looking downstream

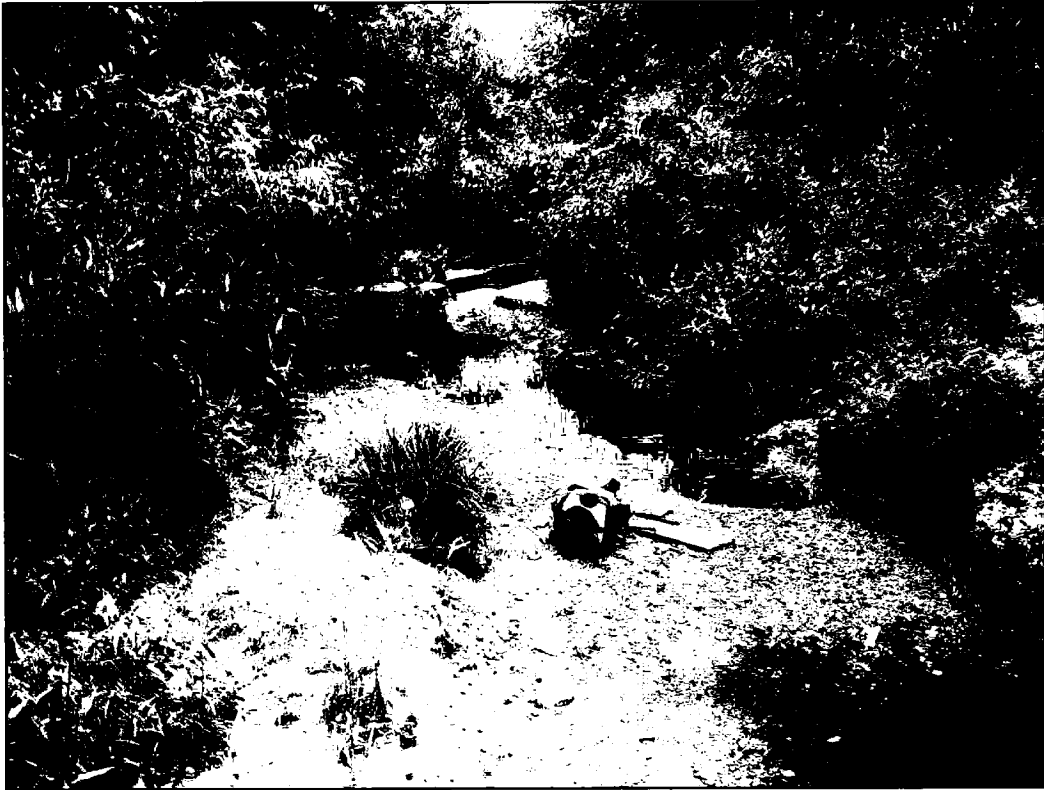
Assessment Point No. 2 – Looking upstream

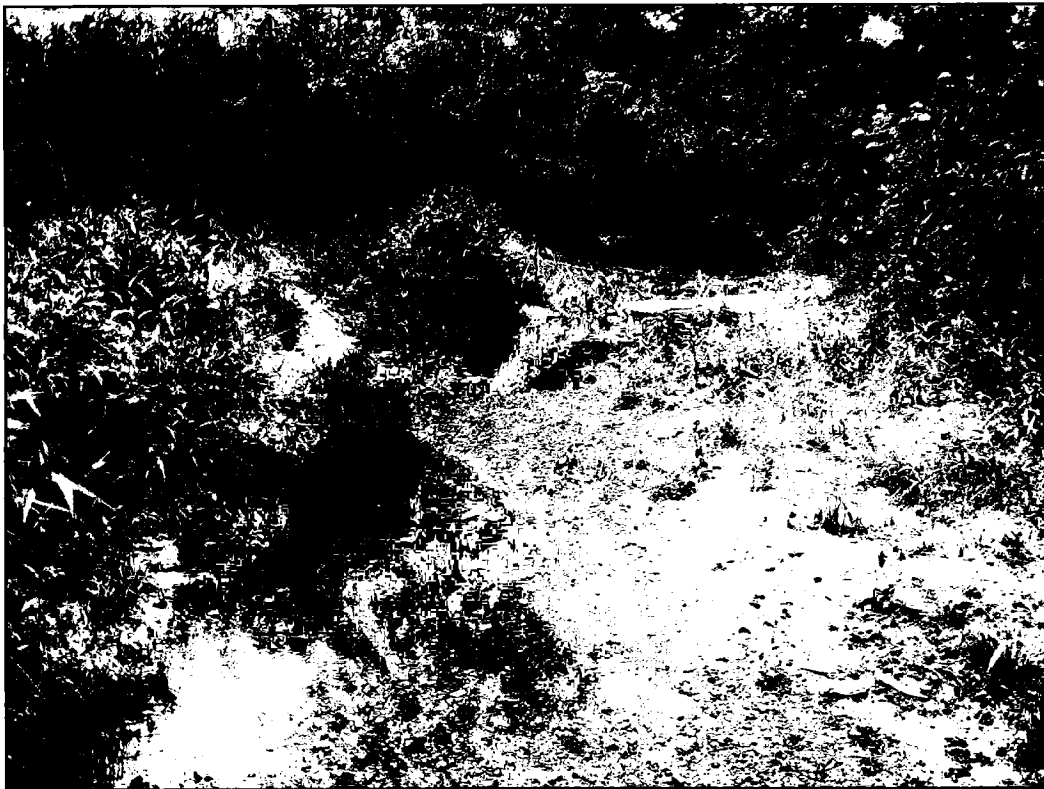
Assessment Point No. 2 – Looking downstream

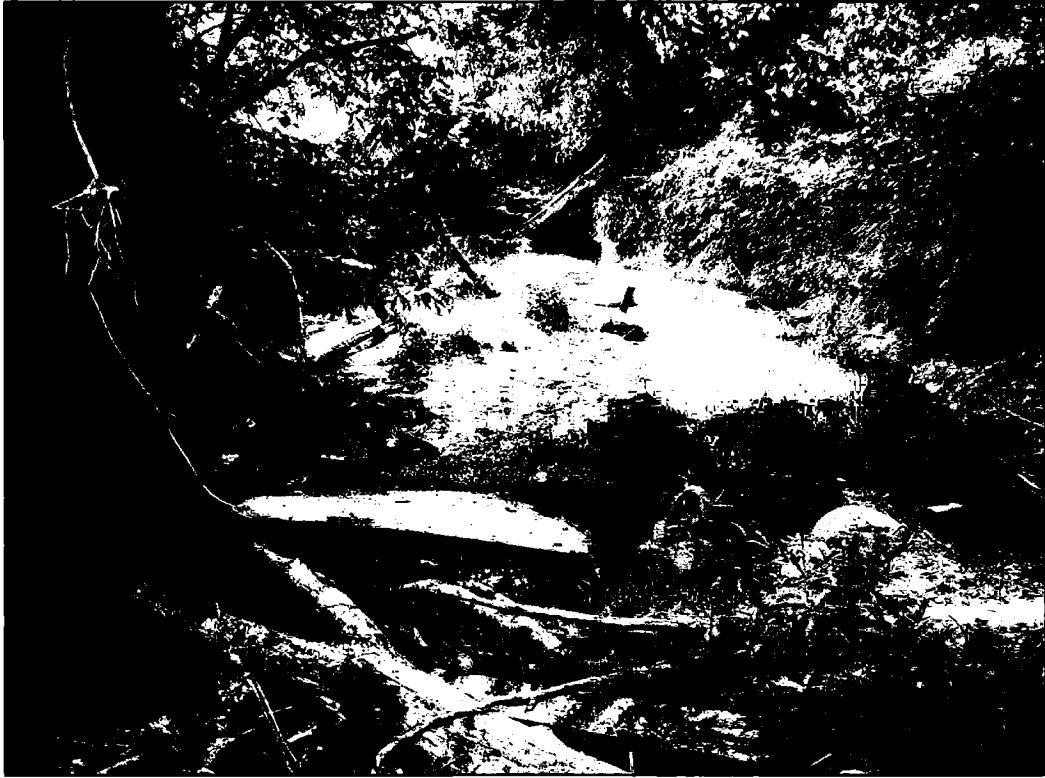
Assessment Point No. 3 – Looking upstream

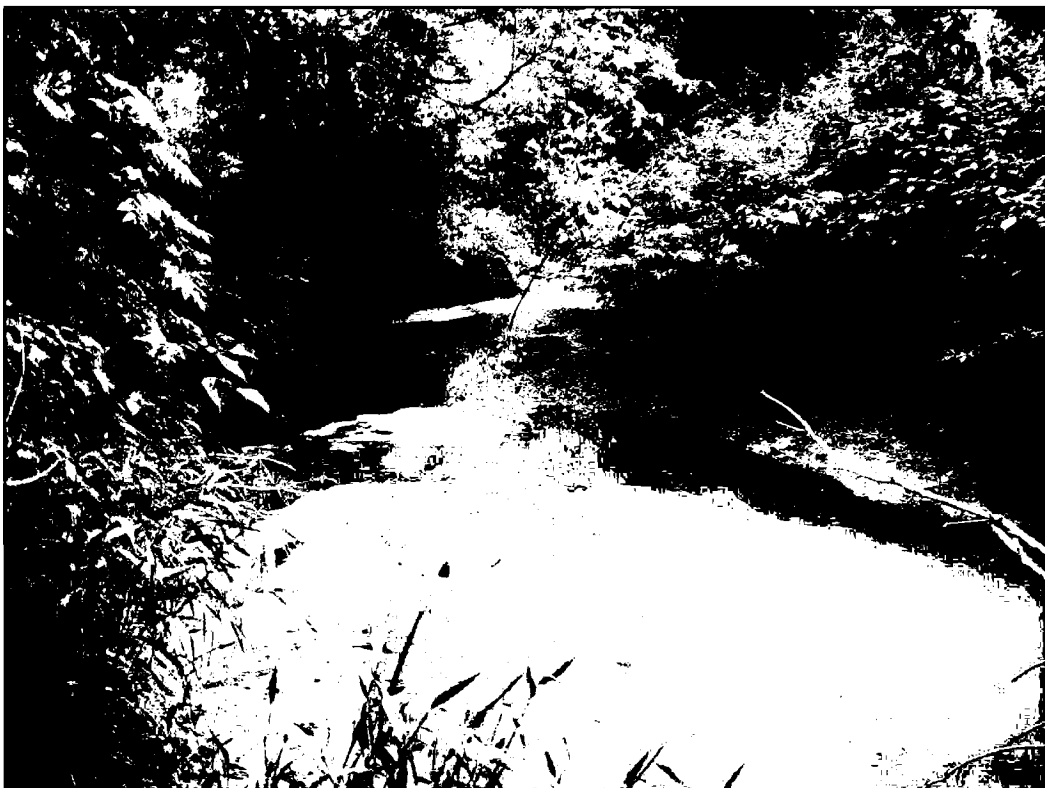
Assessment Point No. 3 – Looking downstream

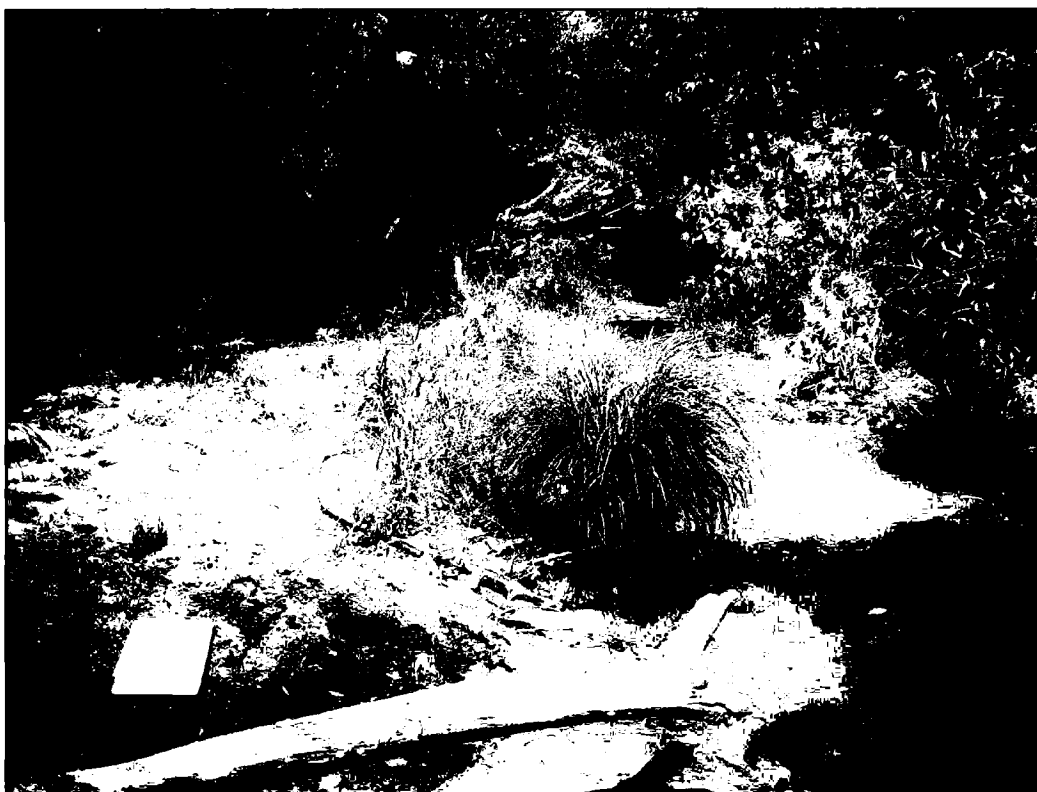
Assessment Point No. 4 – Looking downstream

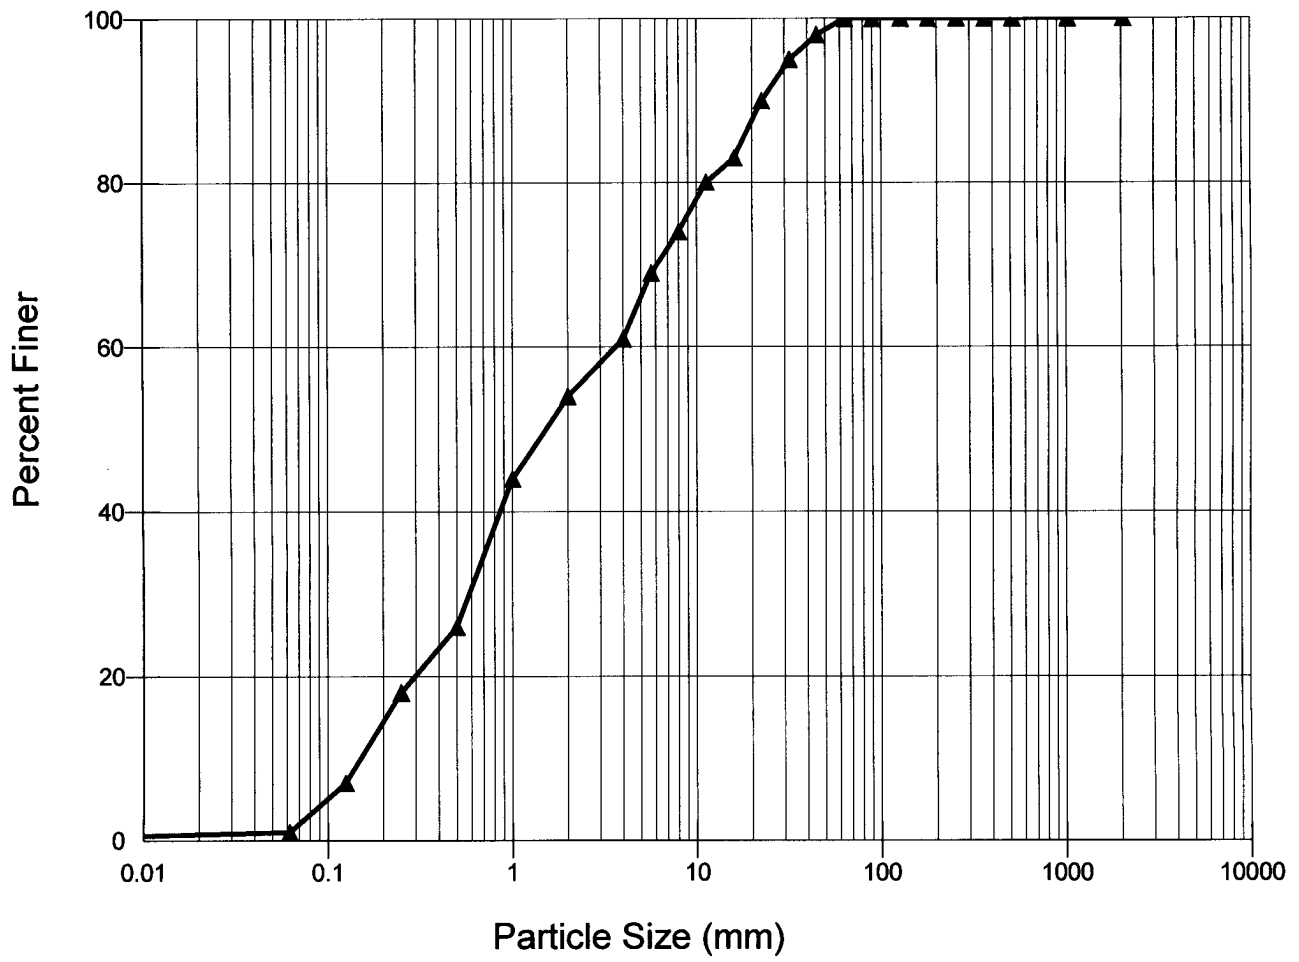
Total Particles = 100.

The existing stream substrate consists predominantly of sand and gravel, with lesser amounts of silt/clay material present. Information on the particle size distribution is found in Appendix 3. The existing channel has relatively little morphologic variation compared to natural channels, but a riffle/pool morphology is present.

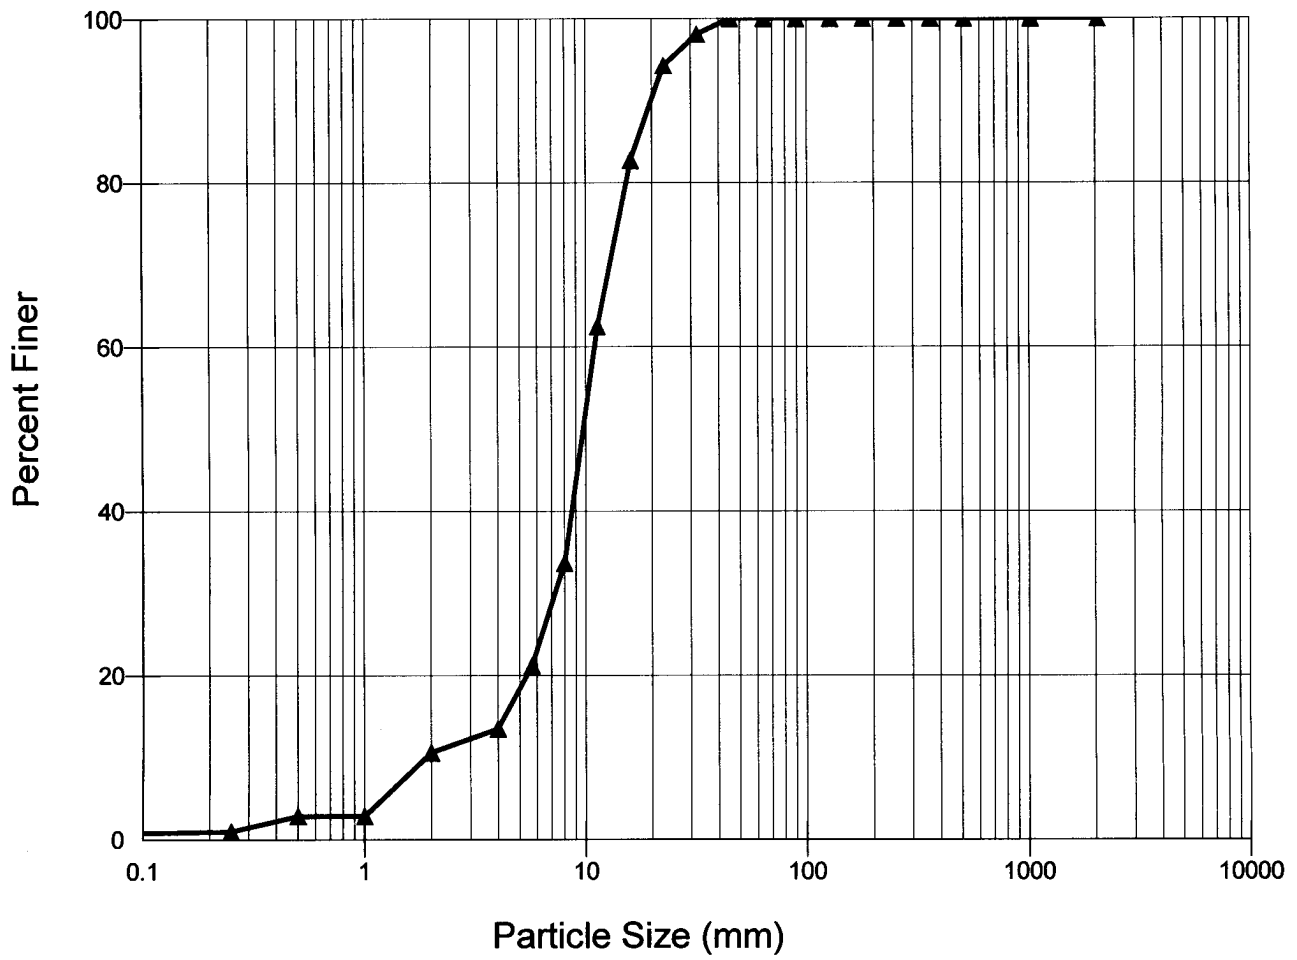
River Name: East Fork - Little Sandy
 Reach Name: Reference
 Sample Name: Active_Riffle
 Survey Date: 07/03/2008

Total Particles = 104.

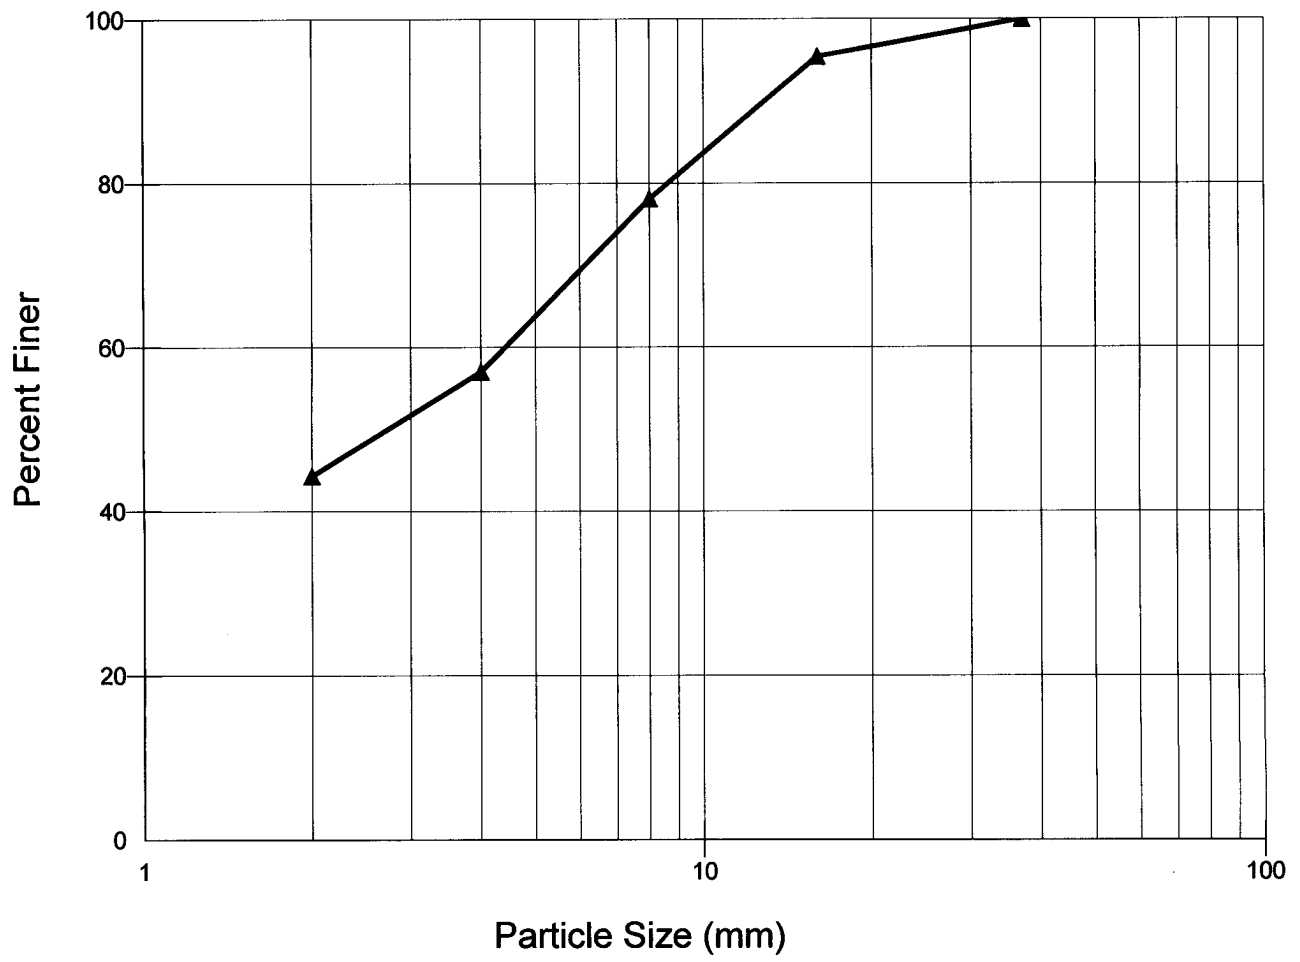
River Name: East Fork - Little Sandy
 Reach Name: Reference
 Sample Name: Bar_1
 Survey Date: 07/03/2008

Size(mm)	weight
Particle 1:	37	35
Particle 2:	25	15
